**This form will report compliance with your permit as determined by an Environment Agency officer**

Site	Frog Island			Permit Ref	403185		
Operator/ Permit holder	S WALSH & SON LIMITED						
Date	02/04/2024			Time in	11:35	Out	12:30
What parts of the permit were assessed	F						
Assessment	Site Inspection	EPR Activity:	Installation	Waste Op	X	Water Discharge	
Recipient's name/position	Director						
Officer's name	Henry De Havas Morais, Emma Gunning			Date issued	18/04/2024

The purpose of the visit was to investigate multiple reports of dust emissions leaving the site.

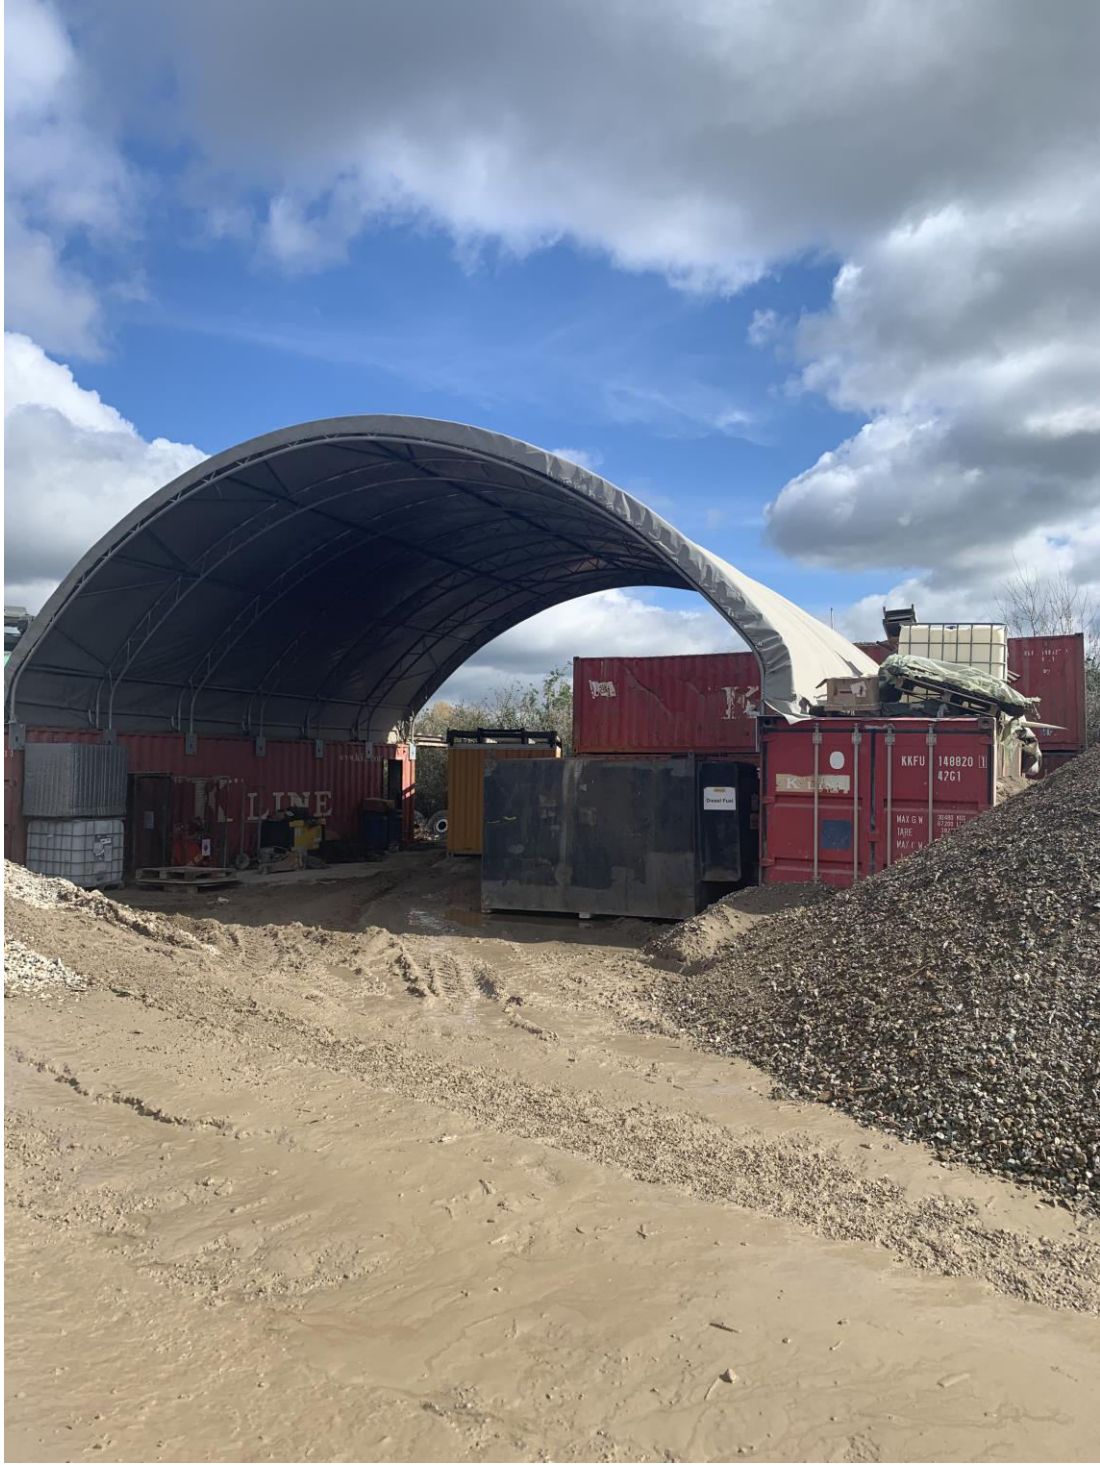
Officers spoke with SO about the dust complaints and they stated they were aware of the issue. SO believed the primary cause of the dust emissions was a gap in the site boundary fence located behind a hanger style storage area on your left as you enter the operations area of the site from the main entrance (See Photo 1). SO stated that they planned to have this gap filled using a container and some corrugated sheeting they already had on site. SO showed officers the materials in question and stated that it would be installed by the following day (Wednesday 03/04/24). Operations were in progress during the time of inspection and officers witnessed dust being produced both from the ends of screening conveyors and as a result of the waste landing from a significant drop (approximately 4m) into its segregated waste pile. These operations were being undertaken within 10m of the site boundary and some dust was witnessed to have been leaving site.

During the time of the inspection SO stated that they believed the cause of the emission was the gap in the eastern boundary behind the hanger type storage unit. This emphasises the sites awareness of said dust emissions. Although SO stated they had the materials on site and intend to remedy the problem by the next day. As written in the DAP operations must be ceased and/or mitigation implemented with immediate effect. Additionally, the Environment Agency has not been informed by the site of any pollution.

Photo 1: Gap in boundary behind hanger style storage unit.

**Action 3** – To repair the damaged dust netting and to extend the netting across the Eastern, North-Eastern boundary up to the parking area. Send photographic evidence this has been achieved to [henry.dehavasmorais@environment-agency.gov.uk](mailto:henry.dehavasmorais@environment-agency.gov.uk)

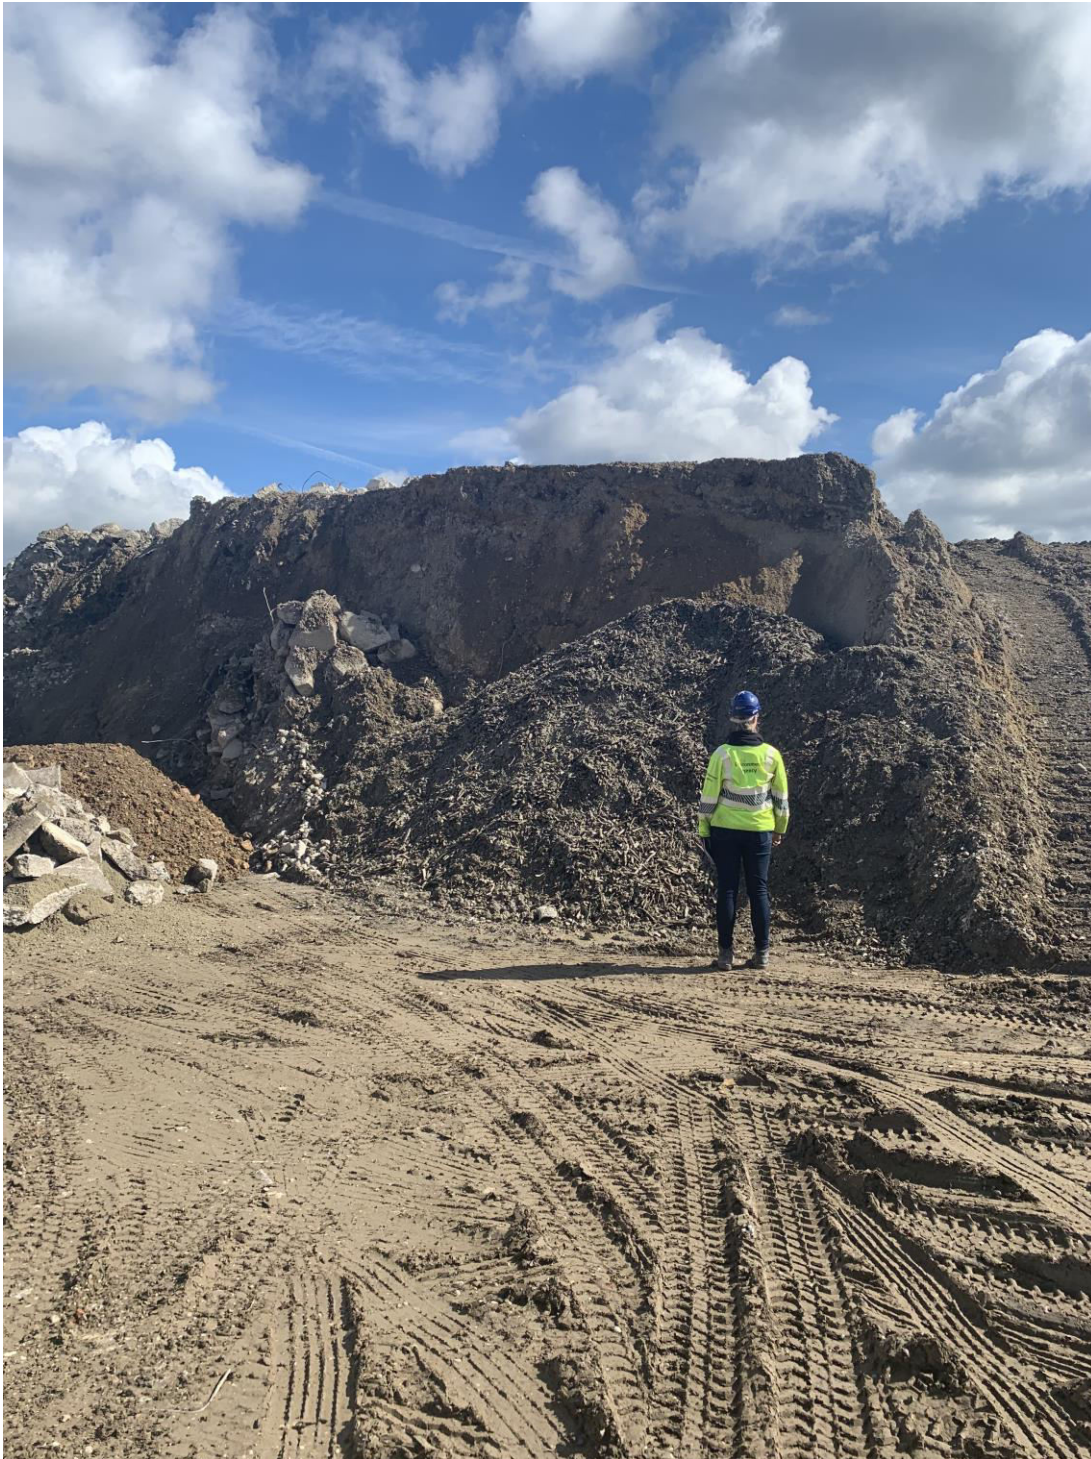
At the time of inspection waste pile heights were seen to be significantly higher than allowed by the sites dust emissions management plan (DEMP). The site DEMP allows for waste piles heights of 3m whereas actual levels ranged from approximately 3m-8m in height (See Photo 2). Much of the waste pile also acts as a platform that plant machinery operates off of. Some of the waste piles were approximately 5m in height built on a waste pile platform approximately 2m in height. In addition, much of the loading operations undertaken by 360 grabbers are executed at the top of these piles further exposing these operations to the effects of wind whipping (See Photo 3). Across the operations area of site there remains to be large quantities of silt and mud however this was not seen to be leaving site.

- *“The stockpiles are maintained below the height of the dust netting. Stockpiles will be a maximum height of 3m.”*
  - During inspection the pile of C&D waste at the north easterly most point of the site was seen to be at a maximum of 8m in height, approximately, and above the dust netting located along the site boundary to the west. The overall quantity of waste was significant and rather than singular peaks being found to have exceeded the 3m maximum the majority of the waste on site had been formed into almost 1 combined set of structures containing plateaus and ridges with most approximately ¼ of all waste to have resided above the 3m maximum height.

Photo 2: Waste piles already on 2m high waste platform, approximately 5m in height.

**Action 1** – To reduce stockpiles of waste to below the 3m limit outlined in the DMP. Send photographic evidence this has been achieved to [henry.dehavasmorais@environment-agency.gov.uk](mailto:henry.dehavasmorais@environment-agency.gov.uk)

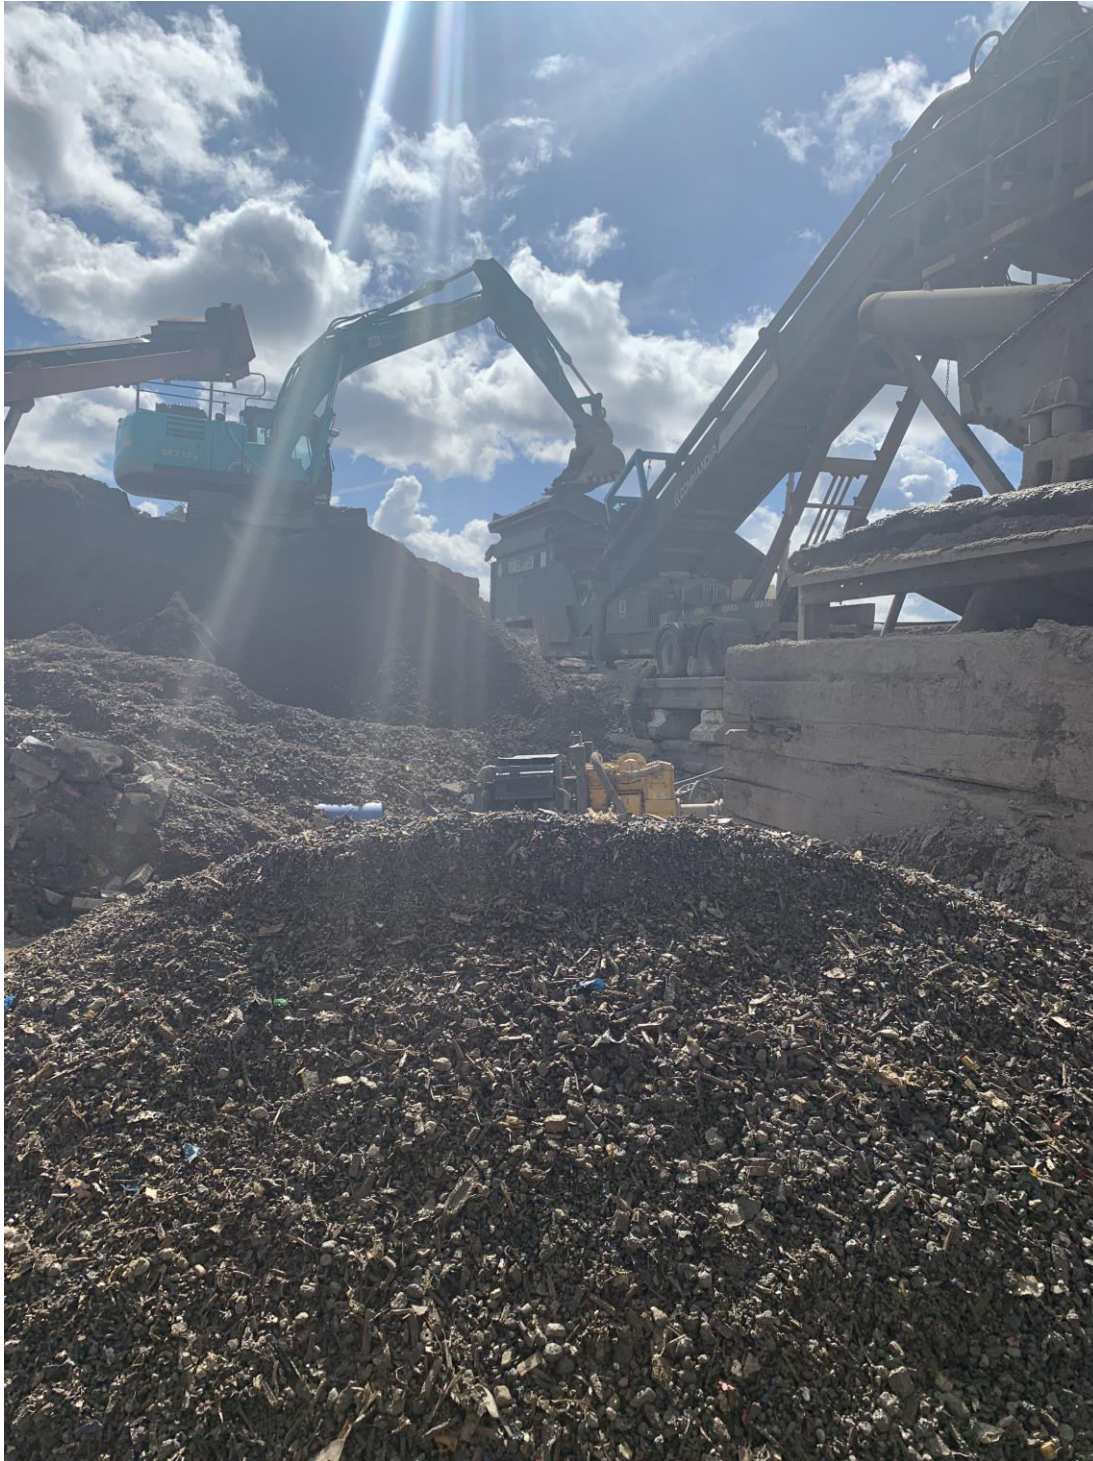
- *“Drop heights from crusher, screener and vehicles will be kept to a minimum. Maximum drop height will be from the screener, approximately 2.56m.”*
  - During the time of inspection drop heights from operating conveyors were seen to be approximately 4m in height and actively causing dust plumes to be emitted upon impact to the pile below.

Photo 3: 360 Grabber operations being undertaken at height. Approximately 3m from plant base.

**Action 2** – To lower conveyor heights during operations to be inline with the requirements outline in the DMP with a maximum of 2.56m. Send photographic evidence this has been achieved to [henry.dehavasmorais@environment-agency.gov.uk](mailto:henry.dehavasmorais@environment-agency.gov.uk)

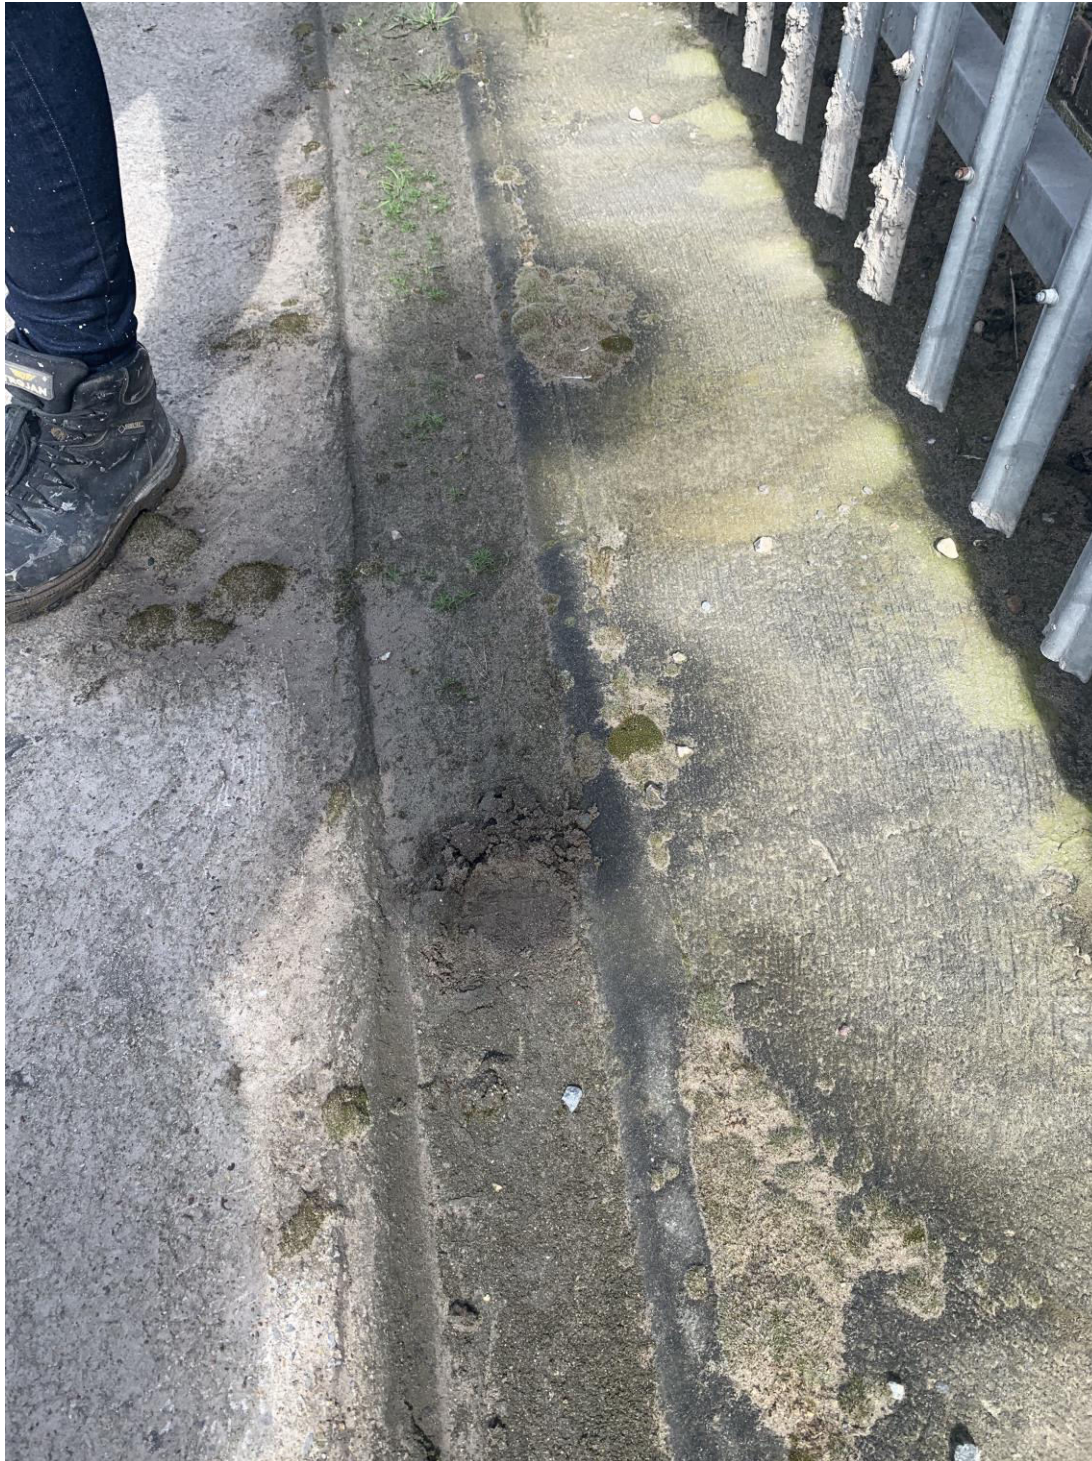
Once the site inspection itself had been completed officers then walked the perimeter of the sites boundary to substantiate complaints of dust emissions. When patrolling Ferry Lane, the road that runs in tandem to the site boundary, deposits of dust were found in the drainage gullies (See Photo

4) of the pavement at a quantity sufficient enough for plant life to grow. Dust was also seen on 4 vehicles in a private car park, with open wire fencing, directly opposite the rear of the hanger style structure. As such, it is clear that the dust suppression systems present, along with the mitigative techniques currently employed on site are not sufficient to reduce dust emissions caused during operations.

Photo 4: Dust accumulation in pavement drainage gully.

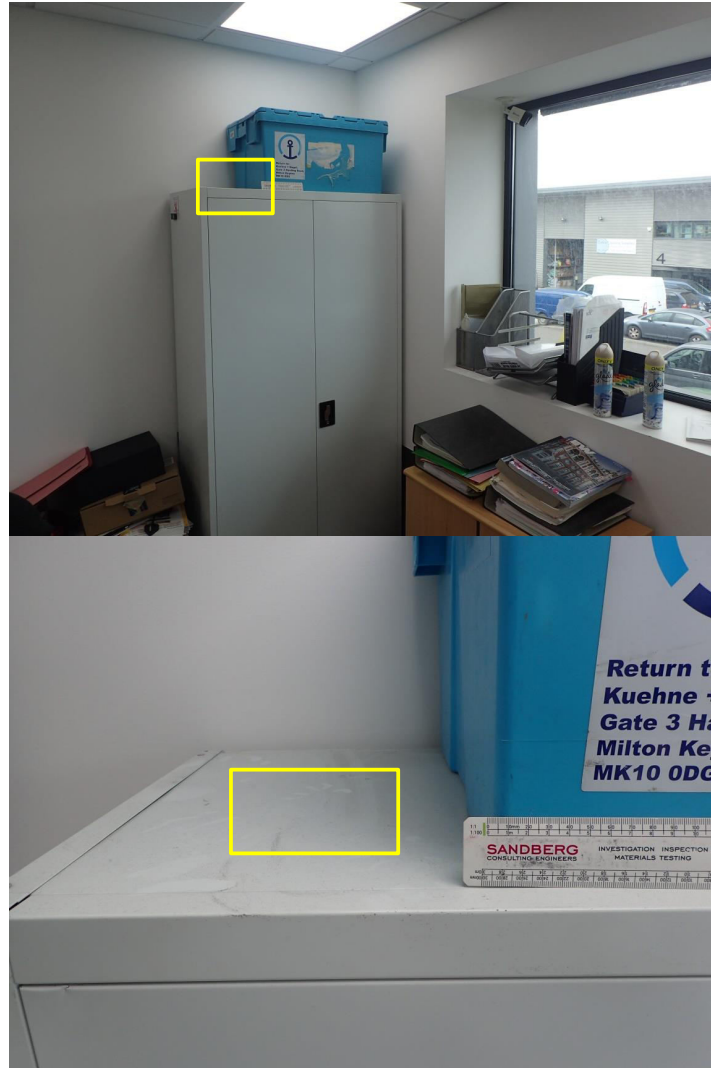
Figure A2

Sample K16819/2

Sample location: Unit 12 office cabinet.

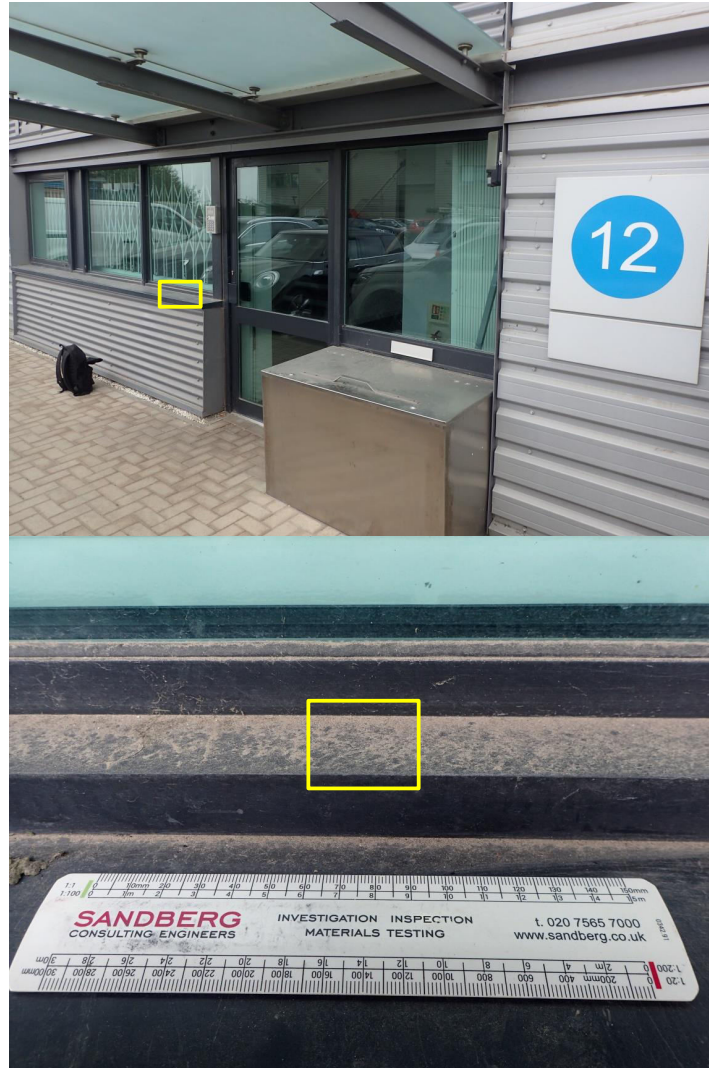
Figure A3

Sample K16819/3

Sample location: Outside Unit 12 window sill.

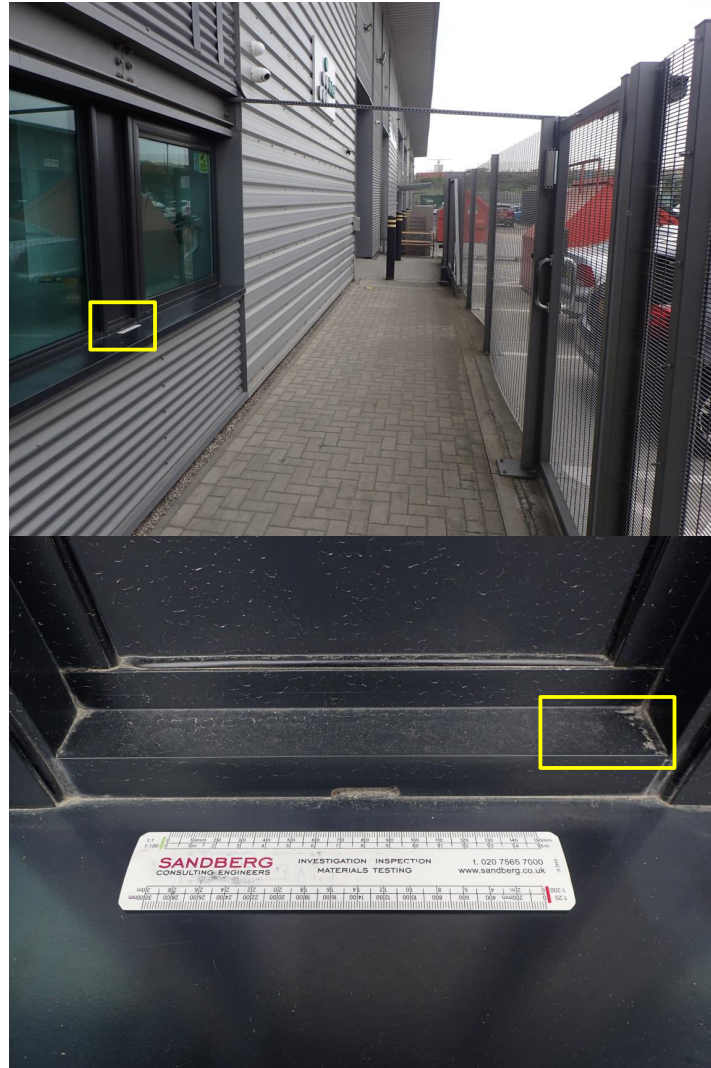
Figure A4

Sample K16819/4

Sample location: Outside Unit 11 window sill.

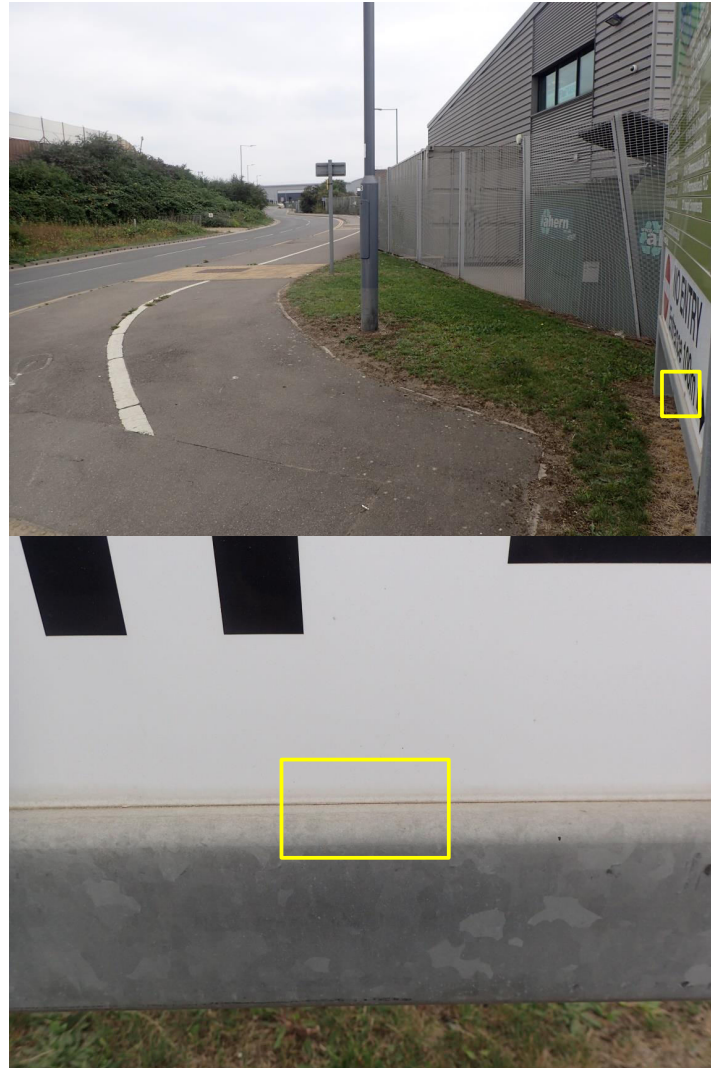
*Figure A5*

Sample K16819/5

Sample location: Estate entrance sign.

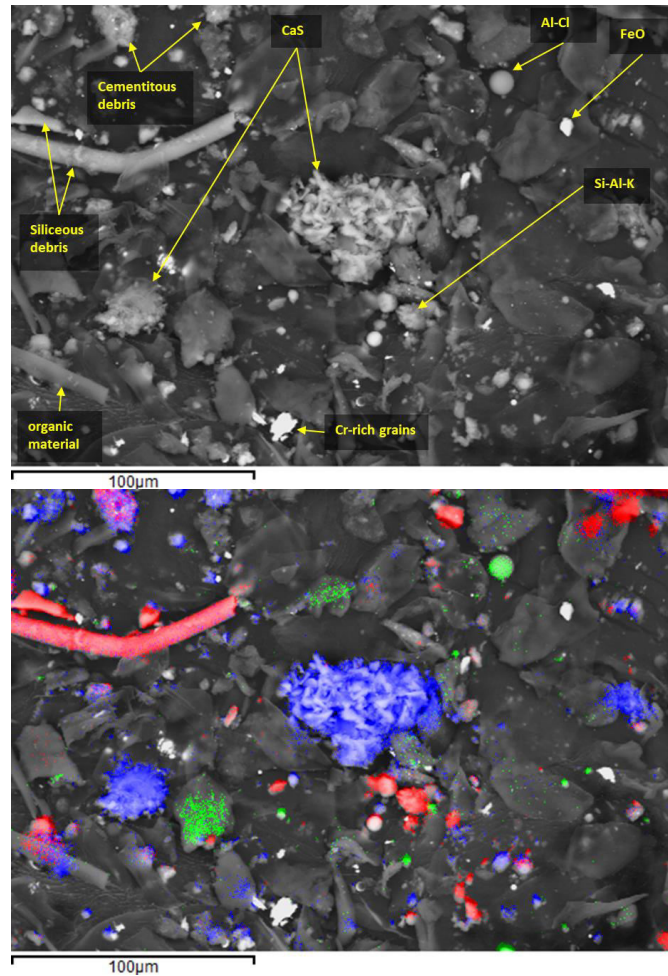
Figure C2

Sample: K16819/2

Location: Unit 12 office cabinet, in office area affected by dust

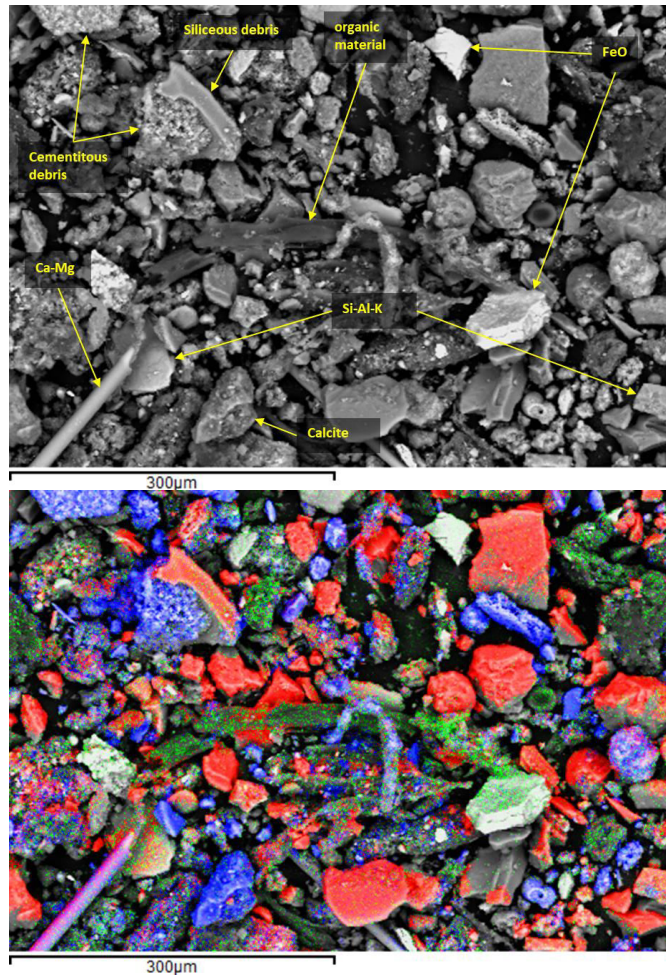
Figure C3

Sample: K16819/3

Location: Outside Unit 12 window sill, on site area affected by dust

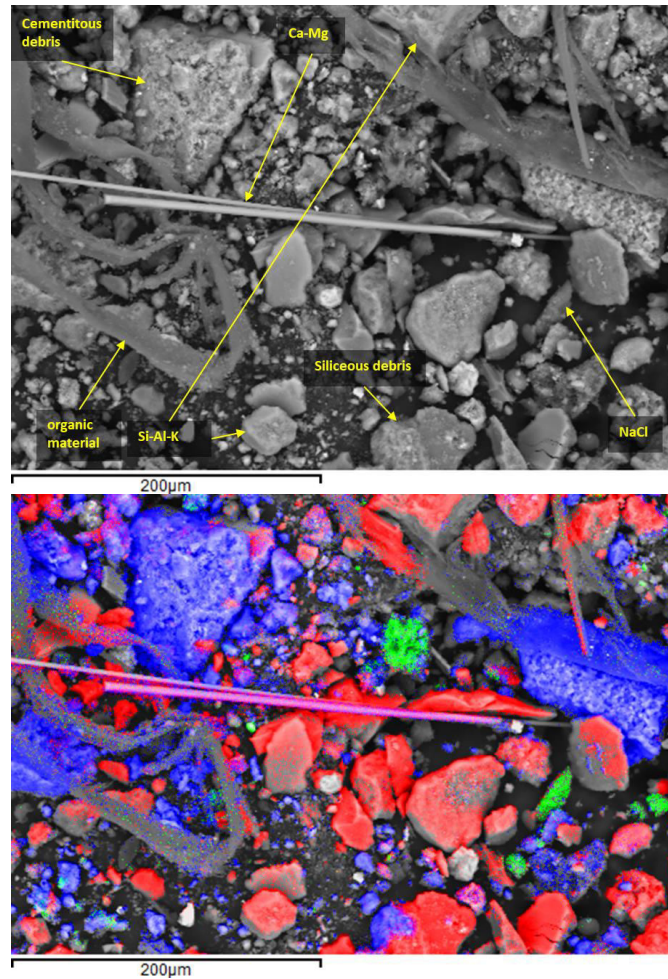
Figure C4

Sample: K16819/4

Location: Outside Unit 11 window sill, on site area affected by dust but cleaned within 48 hours

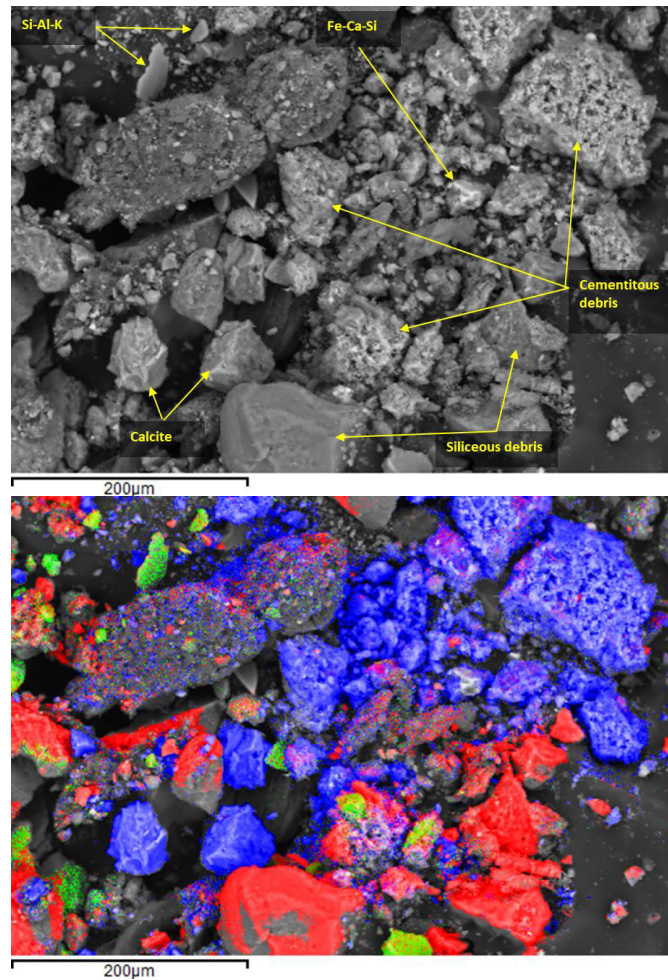
Figure C5

Sample: K16819/5

Location: Estate entrance sign, on site area proximal to plant

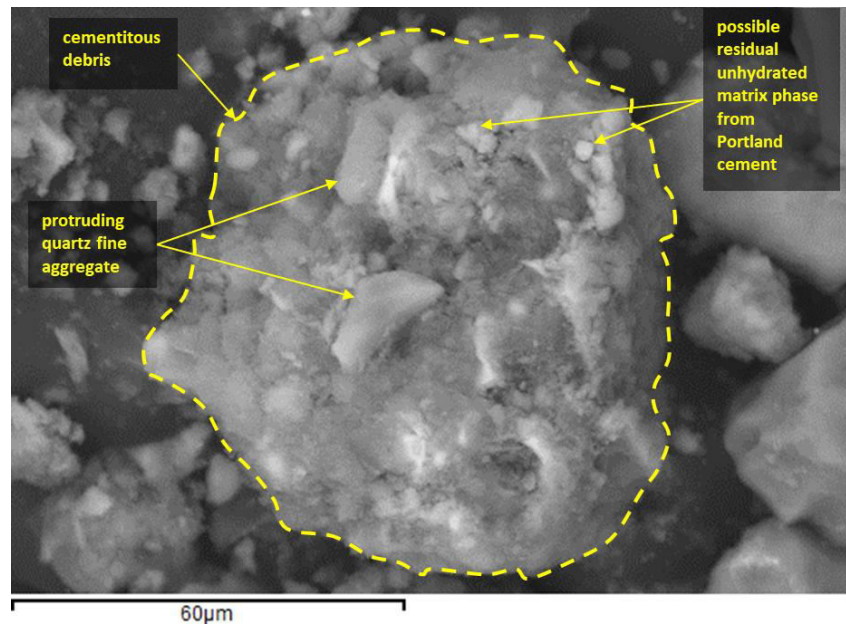
Figure C6

Sample: K16819/5

Location: Estate entrance sign, on site area proximal to plant
