**This form will report compliance with your permit as determined by an Environment Agency officer**

Site	Frog Island			Permit Ref	403185		
Operator/ Permit holder	S WALSH & SON LIMITED						
Date	02/04/2024			Time in	11:35	Out	12:30
What parts of the permit were assessed	F						
Assessment	Site Inspection	EPR Activity:	Installation	Waste Op	X	Water Discharge	
Recipient's name/position	Director						
Officer's name	Henry De Havas Morais, Emma Gunning			Date issued	18/04/2024

The purpose of the visit was to investigate multiple reports of dust emissions leaving the site.

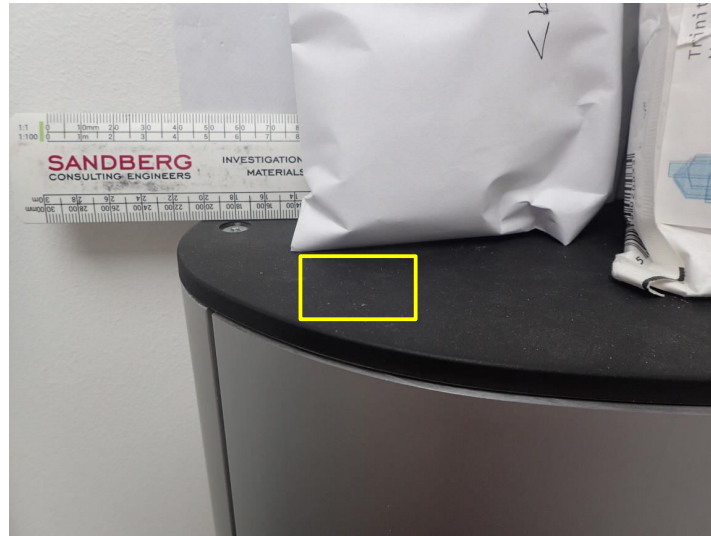
Sample K16819/1

Sample location: Unit 12 office key cage.

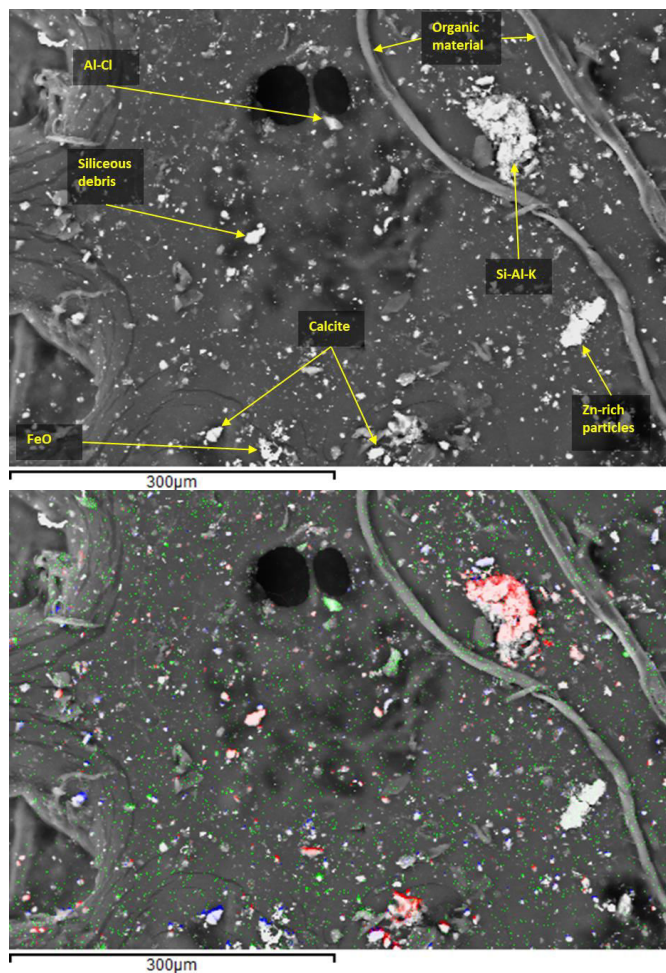
Figure C2

Location: Unit 12 office key cage, in office area unaffected by dust

Backscattered electron image of dust: View showing typical appearance of the dust sample with constituents annotated and an X-ray map illustrating the elemental composition of the deposit (detected silicon, calcium, and chlorine is represented by red, blue and green points respectively).
